# IMPLEMENTATION OF POINT CLOUD AND BIM TECHNOLOGIES IN A CONSTRUCTION WORKFLOW

*A case study of a building project in Yuecheng District, China*

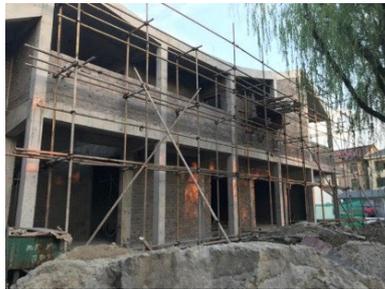
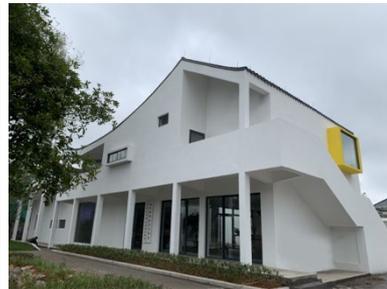
*Figure 1. Image of the investigated building during construction (left);*

*Figure 2. Image of the investigated building after construction (right)*

A case study is conducted to explore the use of BIM and point cloud technologies in a building project. The investigated building is located in Anqiaotou village in Yuecheng District, Zhejiang Province, China. The building is a two-storey concrete structure with masonry walls (Figure 1&2). Its floor area is approximately 380sqm. A BIM model is built in Autodesk Revit, including the disciplines of architecture (Figure 3) and structural engineering (Figure 4) according to the final design intentions.

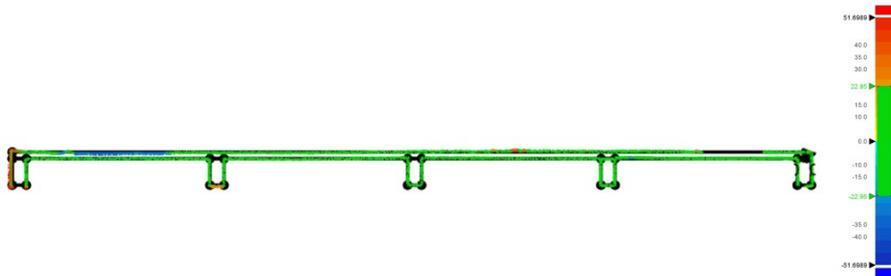
Figure 11. 2D comparison in long section of the slab in the first floor

The first-floor slab is further extracted to be individually compared to its respective point cloud model. The comparison displays a much higher alignment between the two, having 87.11% being within the tolerance of 22.95mm. There are spots showing unevenness of the slab. The reason is possibly due to pieces of occlusion during construction.
